BOYERTOWN RESERVOIR DAM

NDI-PA 00707
PA DER 6-344

PHASE I INSPECTION REPORT NATIONAL DAM INSPECTION PROGRAM

80-7
AUGUST 1979

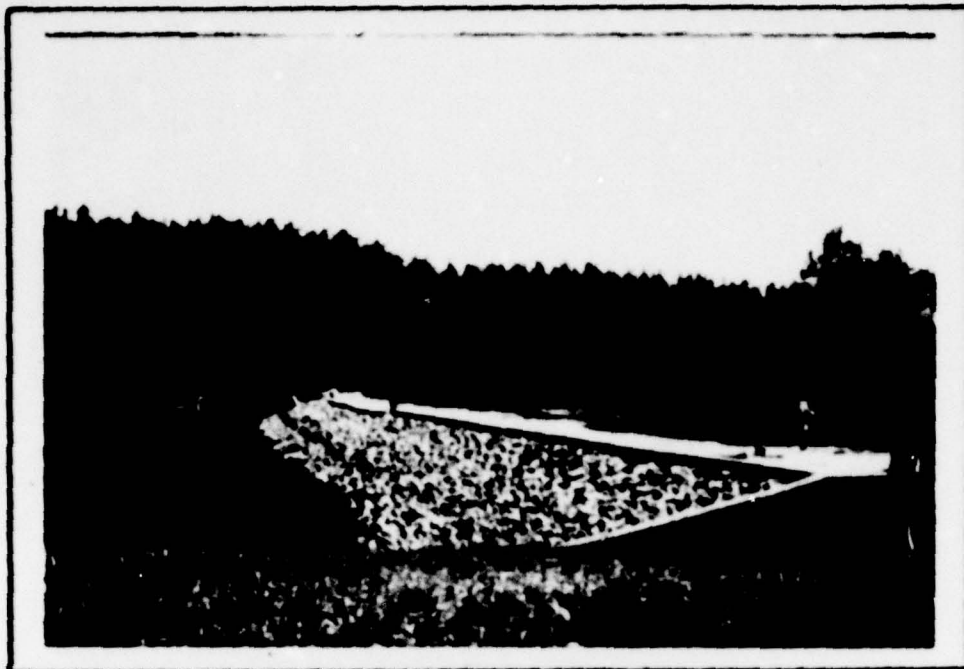
*OVERVIEW OF THE UPSTREAM
FACE OF THE BOYERTOWN DAM*

The riprap cover on the upstream face of the embankment appears to be in good condition. The riprap is fairly well graded, consisting of 6-inch to 2-foot rounded stone.

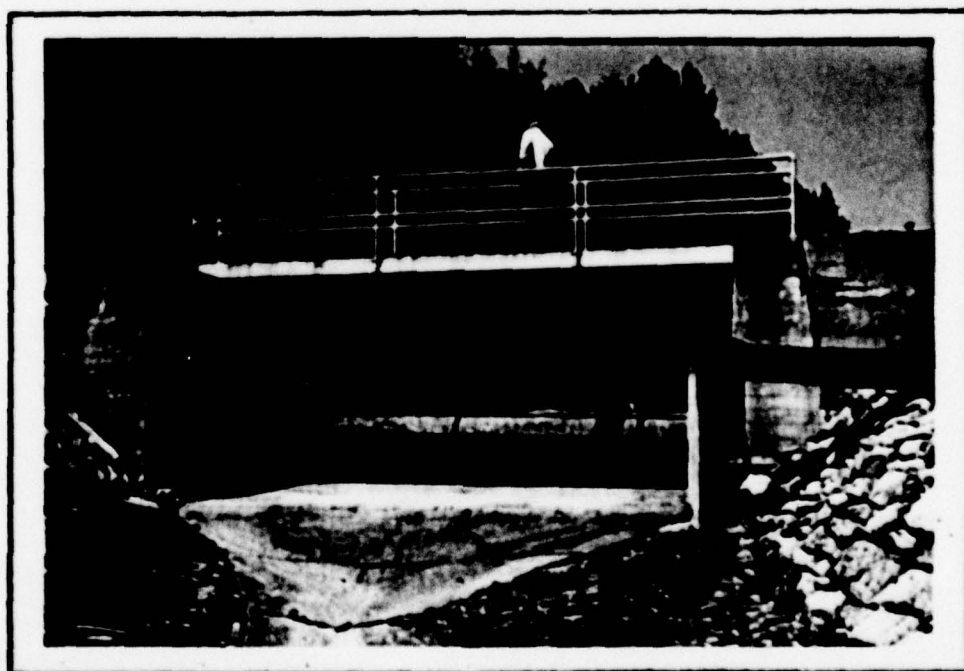
DOWNSTREAM VIEW OF THE SPILLWAY

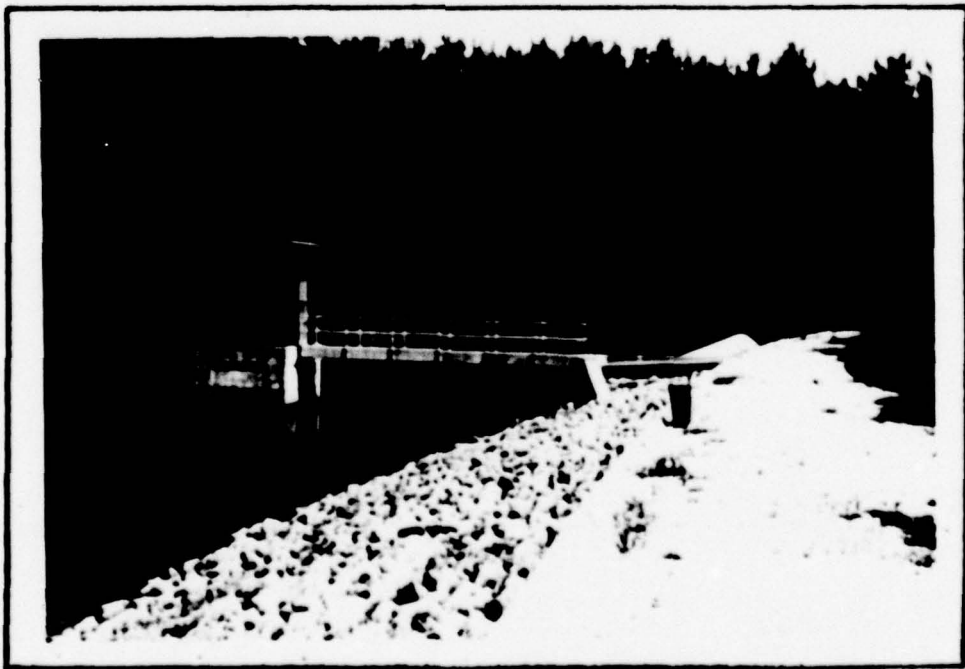
Gravel bordered by concrete curbing on either side covers the top of the dam. The curbing is about 5 inches thick and extends approximately 6 inches above the top of the dam. The curbing is out of alignment near the center of the embankment.

*UPSTREAM FACE AND CREST OF THE DAM
SHOWING THE GATEHOUSE, CATWALK AND
CURBING ALONG THE TOP OF THE DAM*

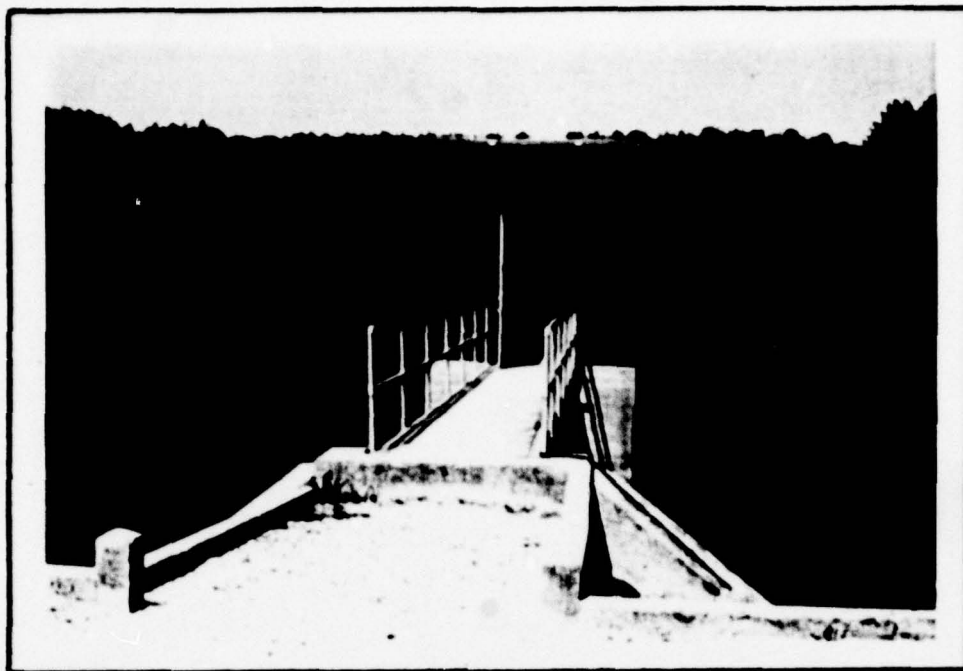
The gatehouse and sluice gate controls appear to be well maintained and in good condition. A concrete foot bridge provides access to the gatehouse from the top of the dam. The reservoir drawdown outlet pipe terminates at the same point as the spillway discharge channel, at the natural streambed about 300 feet downstream.

*VIEW OF THE GATEHOUSE LOOKING
TOWARDS THE RESERVOIR*

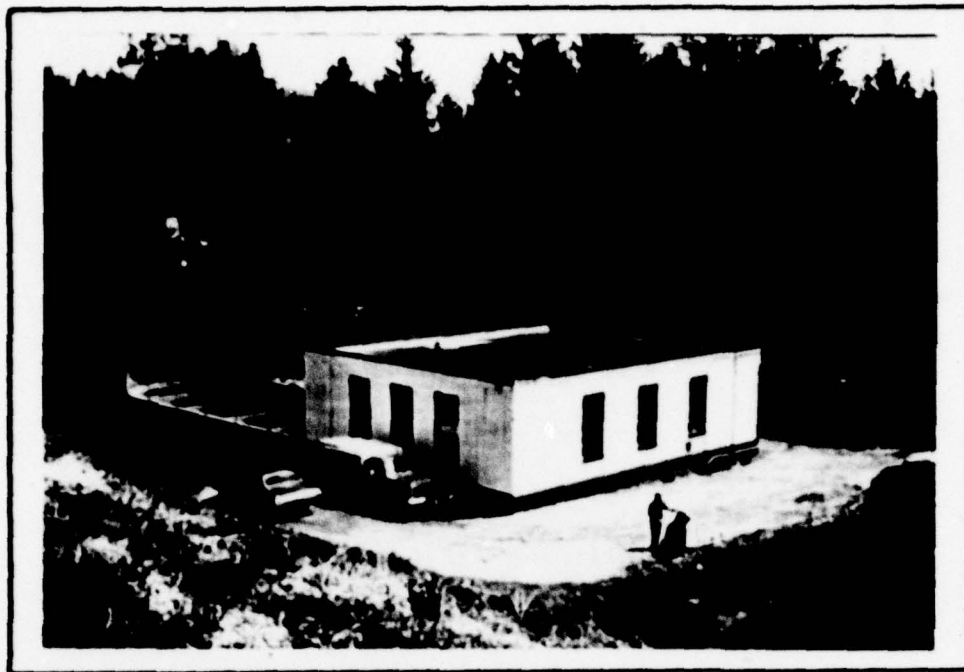
*THE TREATMENT PLANT BUILT IN 1926 LOCATED
AT THE DOWNSTREAM TOE OF THE DAM*

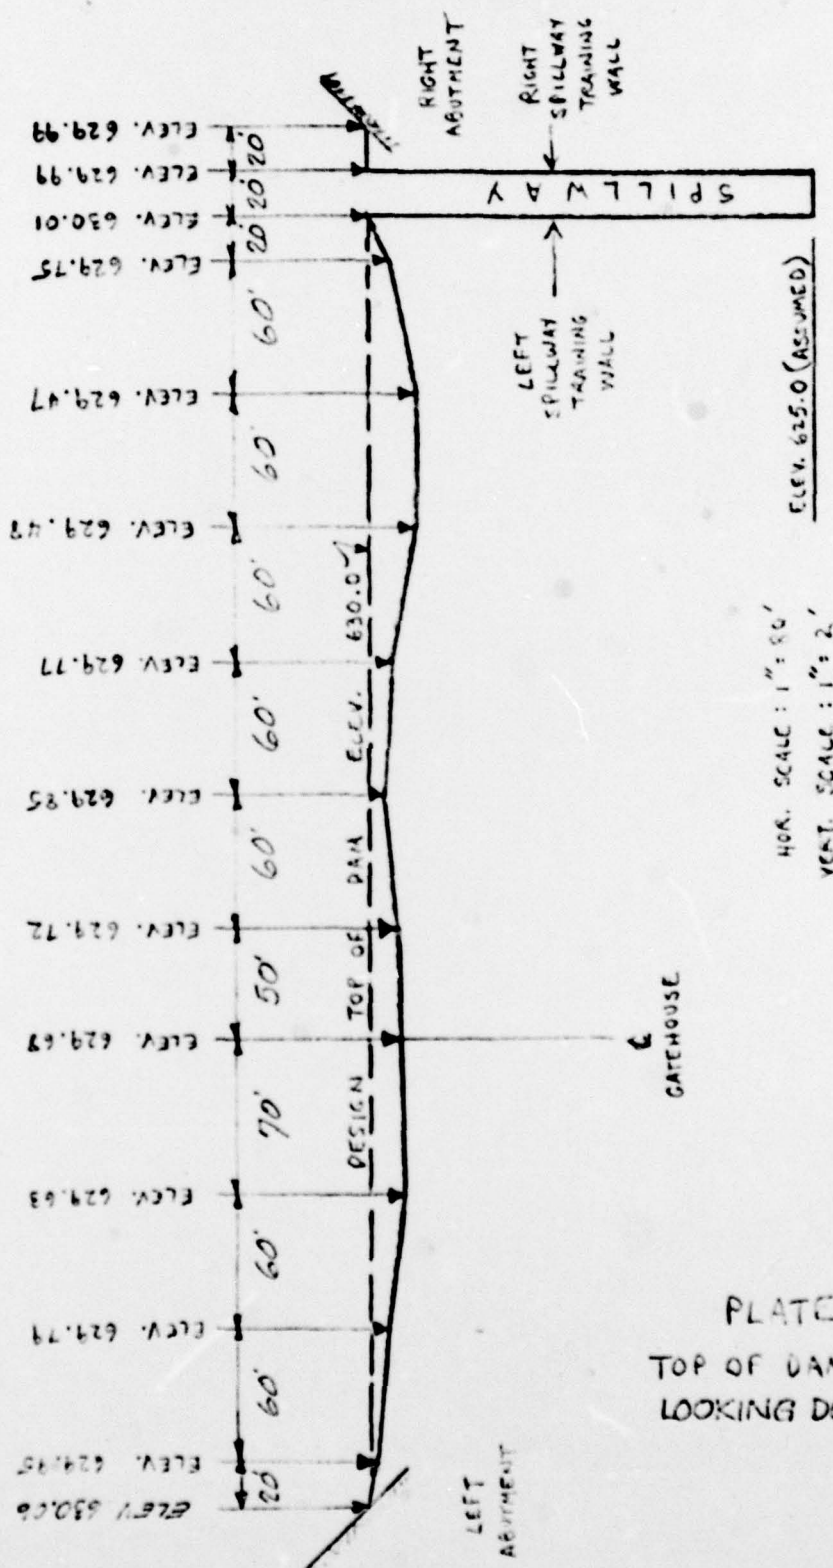
PLATE 7
TOP OF DAM PROFILE
LOOKING DOWNSTREAM

b. Dam. A survey revealed that the top of dam has settled several inches below design elevation along most of its length. A maximum depression of about six inches was observed from approximately 80 to 140 feet to the left of the spillway.

1. The top of the dam should be restored to design elevation as determined by a detailed survey. As a result, the hydraulic capacity of the spillway would be increased by about 60 cfs so that about 45 percent of the PMF could be discharged. Surface monuments should be placed along the top of the dam to monitor any future settlement.
2. Detailed hydrologic and hydraulic analyses should be performed and the spillway capacity should be further increased to make the spillway hydraulically adequate.
